CITY OF BUFFALO AUDIT REPORT

Condition of the Buffalo Parks System

**For the Period
August 10 through August 18, 2005**

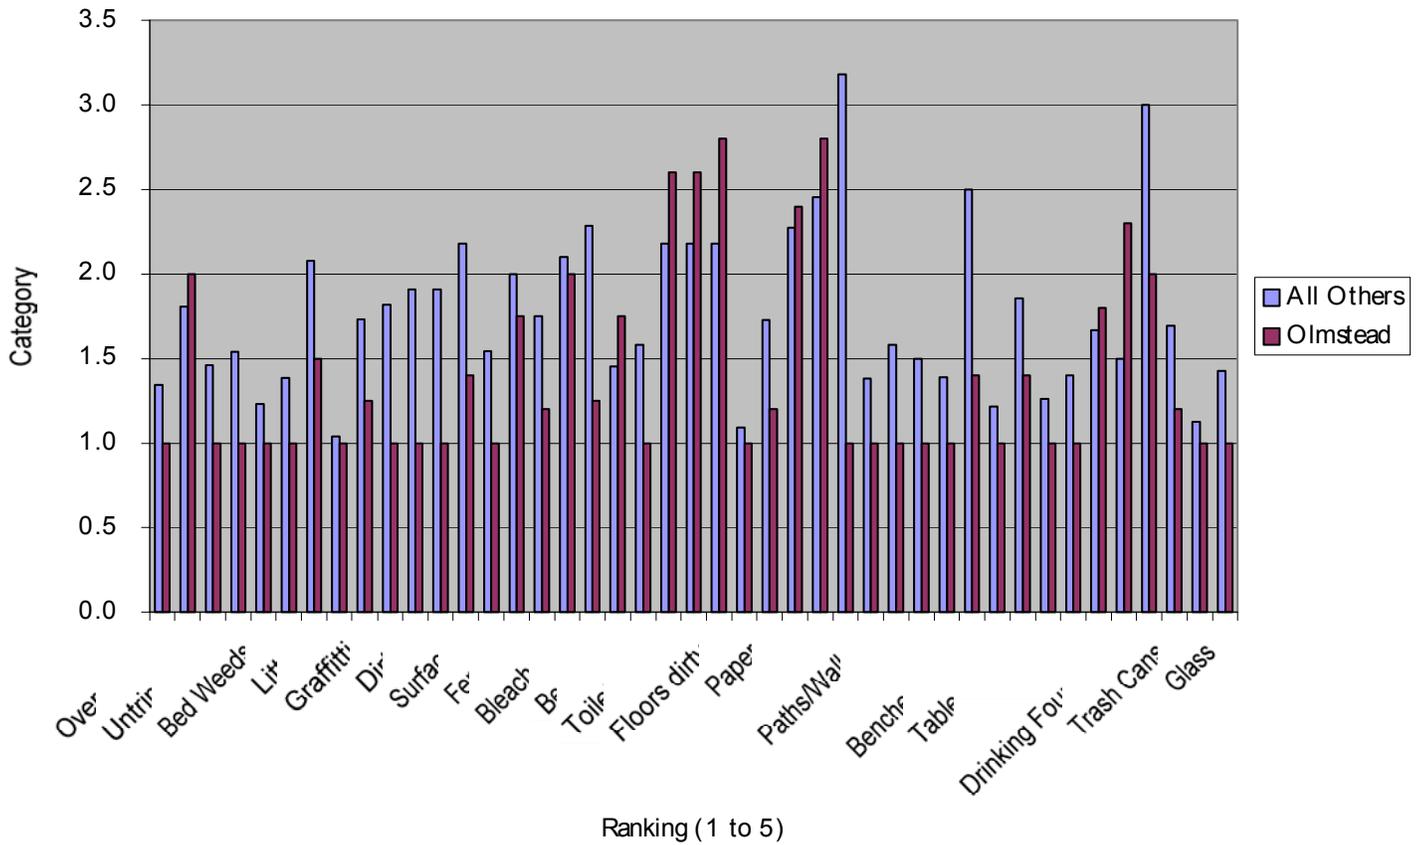
Olmstead v All Others

The above graph lists out the parks reviewed, broken out into to categories – Olmsted Parks and All Others. Reminding the reader that a lower number is a better rating, the Olmsted parks consistently outperform all the other parks, with one notable exception. The Olmsted Parks lost the areas of Public Bathrooms. The audit team’s explanation for this statistical twist is located in the number of City parks that have public bathrooms that are NOT open. Four City locations had public facilities that were locked. Had these facilities been open for the use of the public, perhaps the City ratings would have been much different.

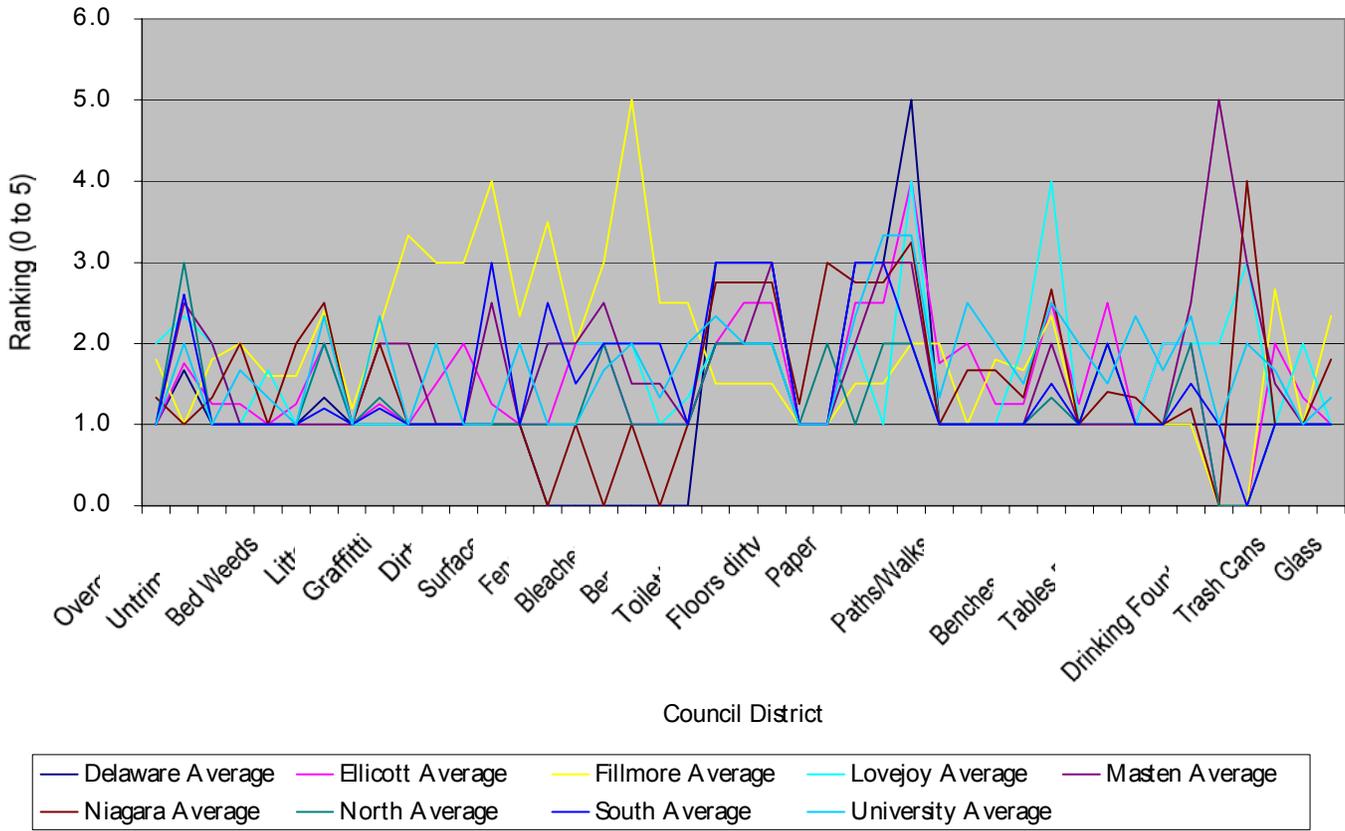
Parks by District Summary

The above graph is of average rankings of the parks reviewed by Council district. This chart includes all facilities reviewed by the audit team, without regard to maintenance responsibility.

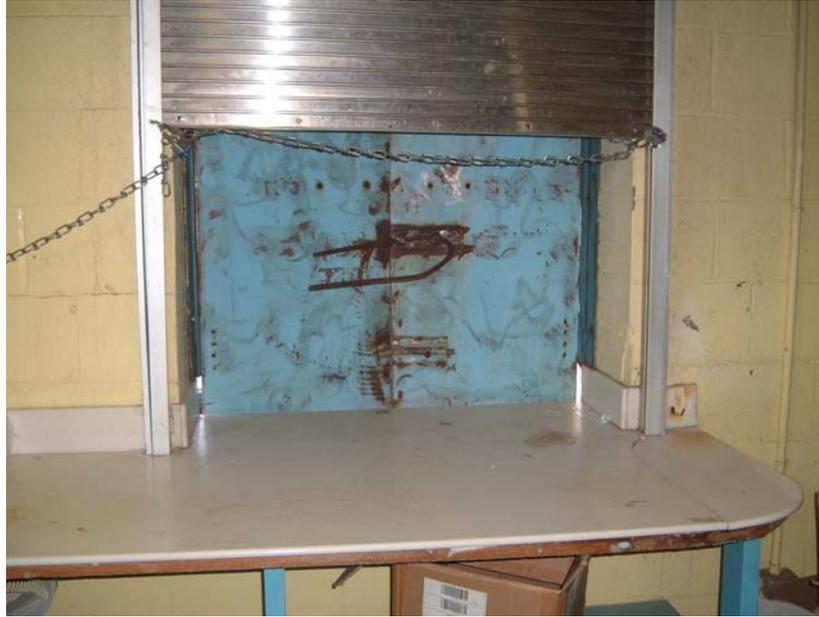
Repairs made to the Masten Park Community Center, located in the Ellicott District. This is the point at which thieves entered the structure. The thieves ransacked the food pantry, ruined pool machinery and stole fencing from the property.

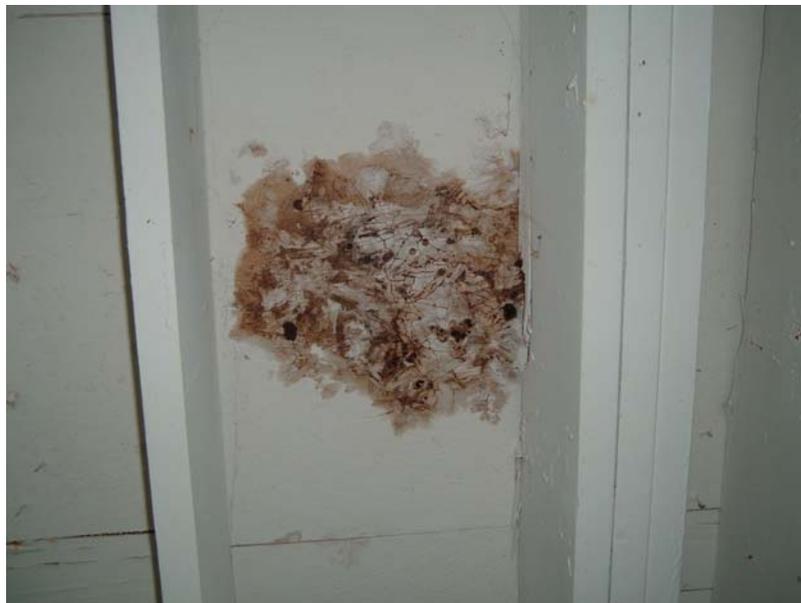
Roof damage to Masten Park community Center

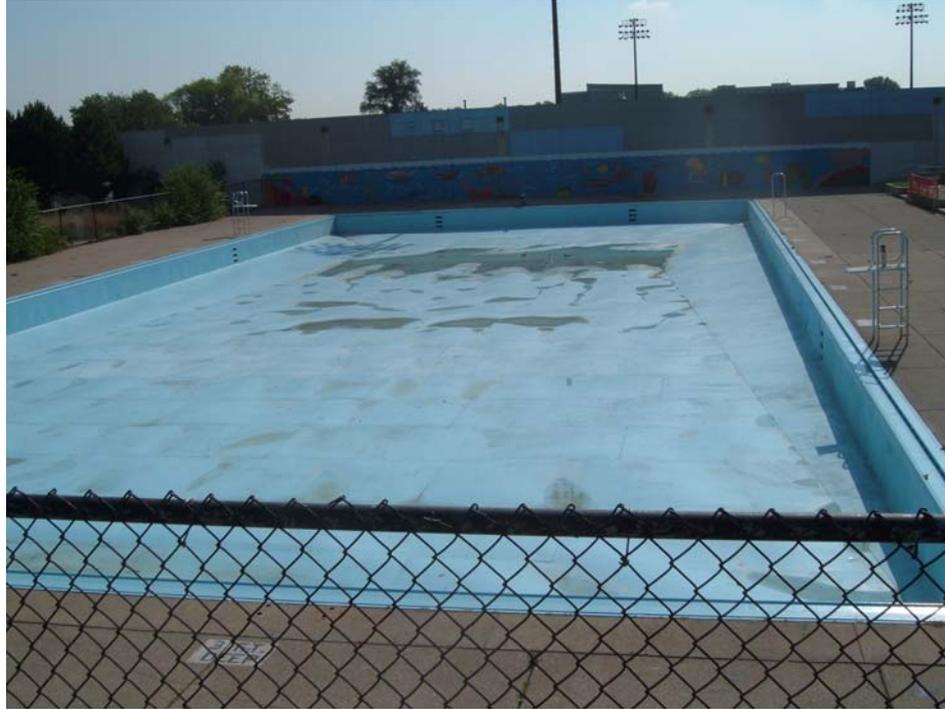
Masten Park pool, unused, unfilled and not likely to be repaired.

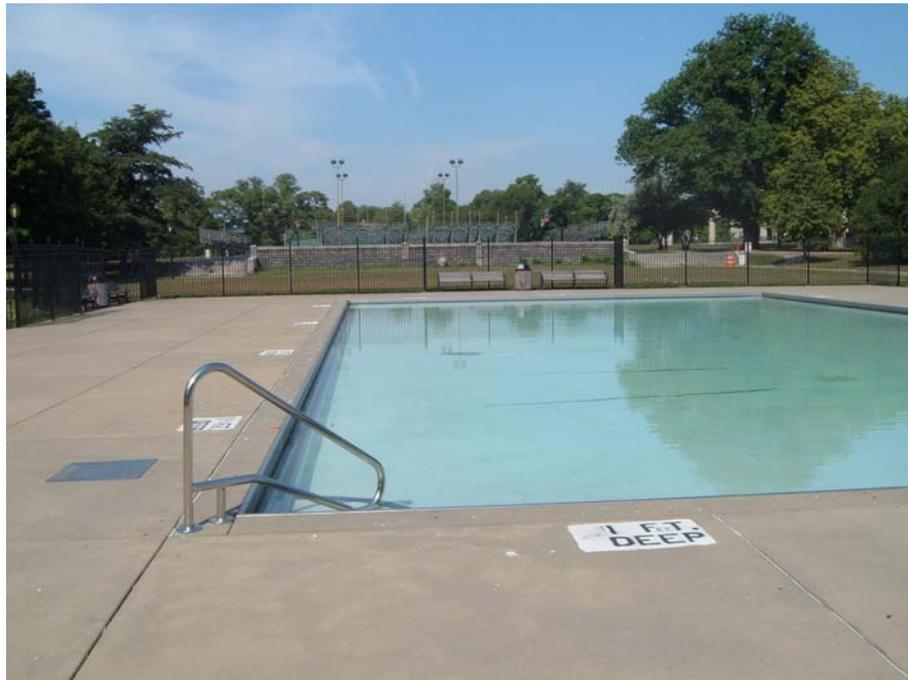
This is Martin Luther King Park in the Masten District. The wading pool was operational when we visited; the lack of swimmers is a result of the time the audit team arrived. The pool was not open to the public when this photo was taken.

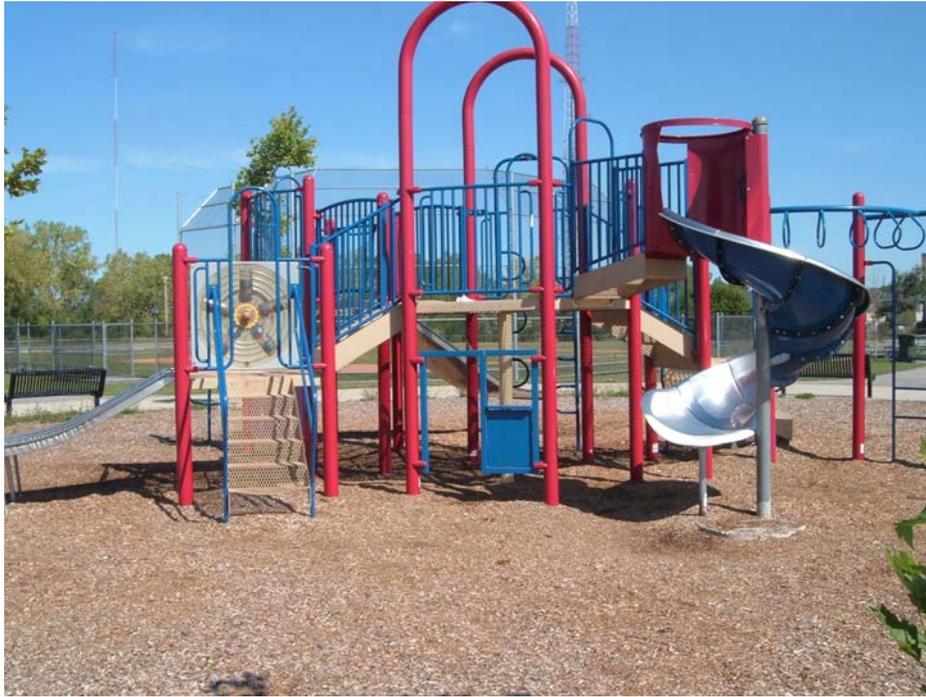
The below photo is from McCarthy Park in the University district. The condition of this play area is excellent.

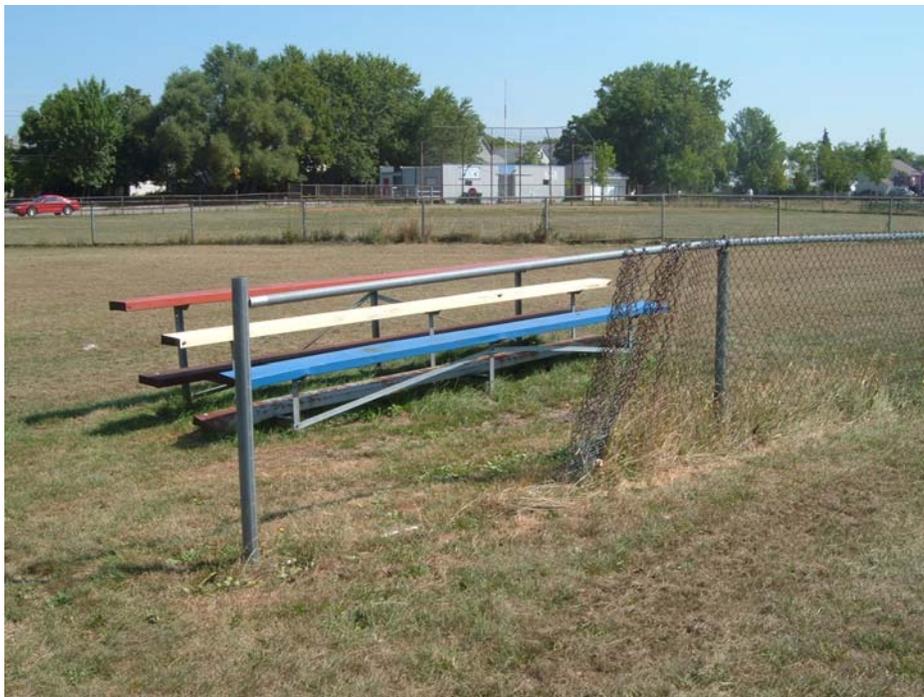
This is a view of Walden Park in the Lovejoy Council District. The fencing and bleachers need maintenance.

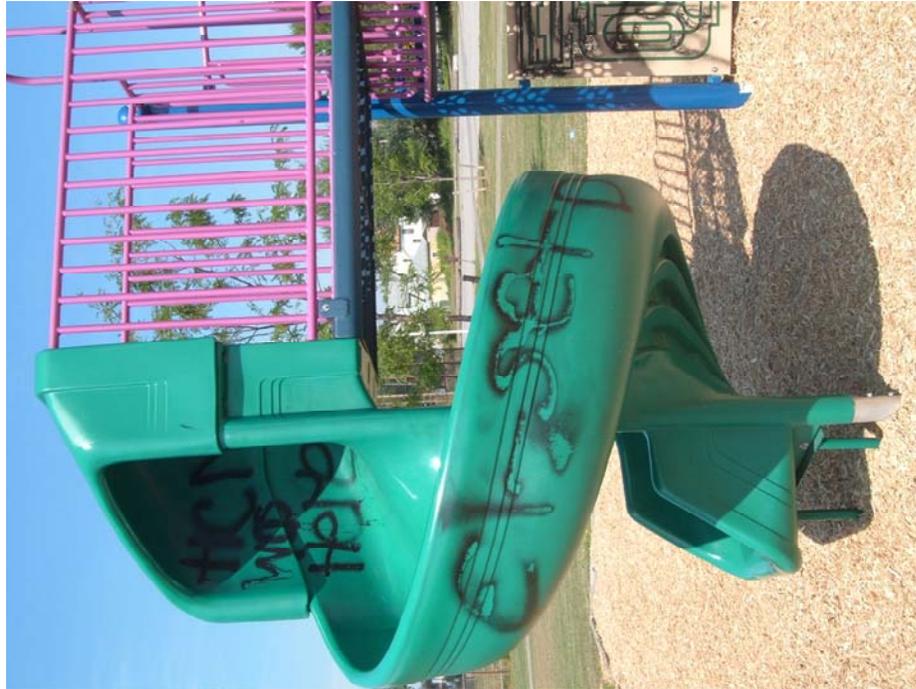
This photo was taken at Walden Park in the Lovejoy District and is of the play area. The slide and other portions of the structure are in good condition, however, the graffiti is deplorable. Please do note the wood chips beneath the play area, this is exactly how such an area should look according to the manufacturer's guidelines.

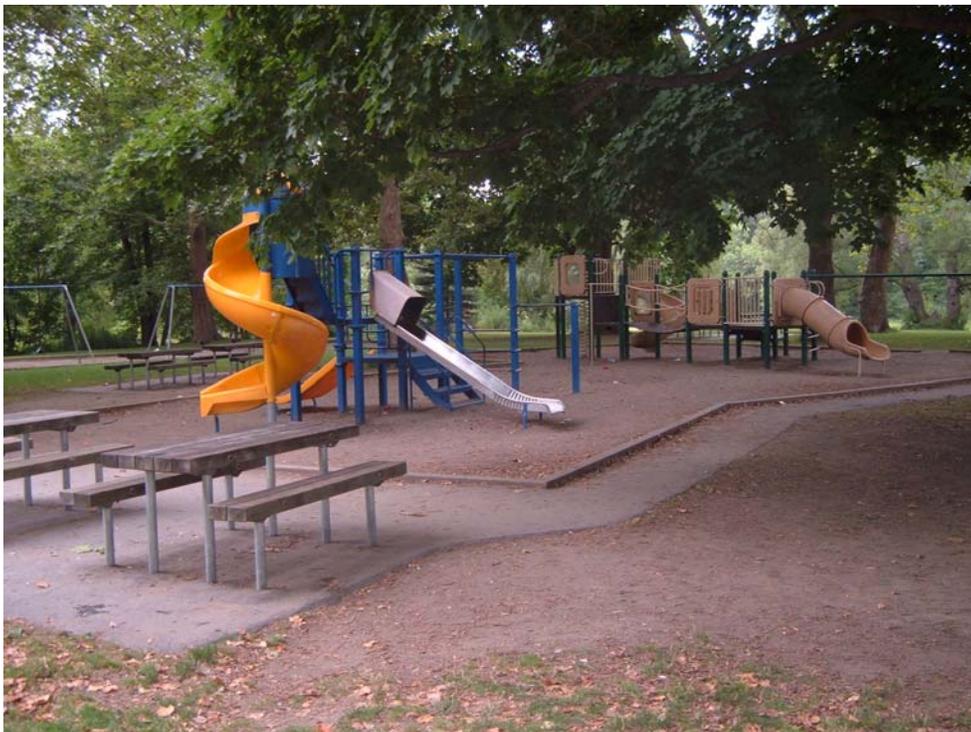
A play area at Cazenovia Park in Buffalo's South Council District. This playground is in excellent condition with the exception of the absence of chips or sand covering the base of the play area.

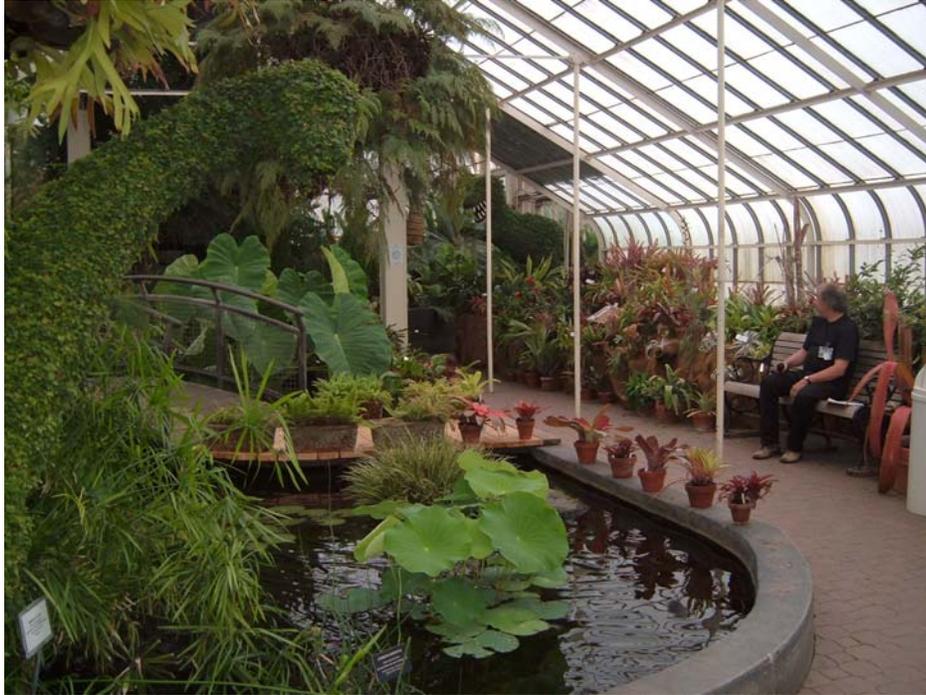
A small portion of the Erie County Botanical Gardens in Buffalo's South Council District. The facility is in excellent condition and was under renovation during our inspection. With respect to the field auditor in the photograph, please note the anomaly – a field auditor sitting down.

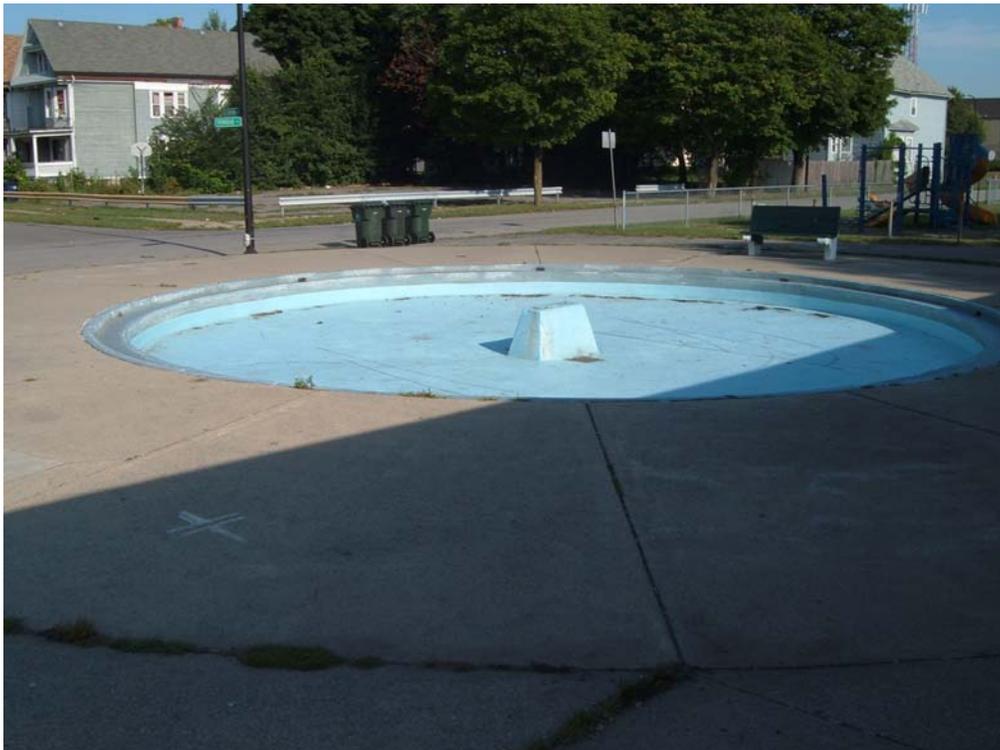
This is the fountain and wading pool in Trinidad Park in the Masten District. It is not operational.

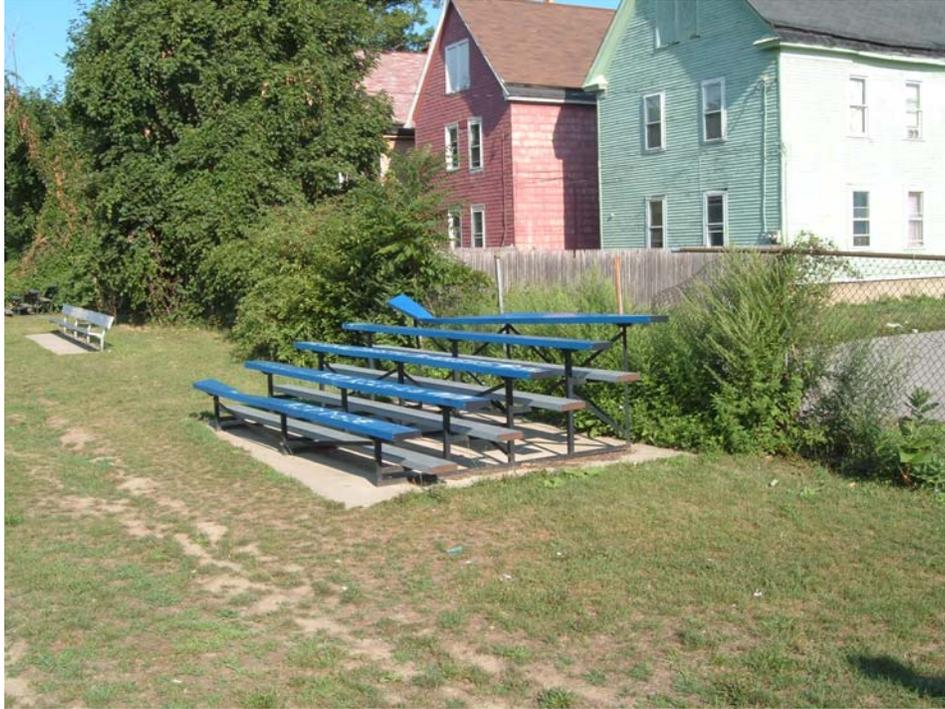
This is another view of Trinidad Park. The bleachers, fencing and grounds all need attention.

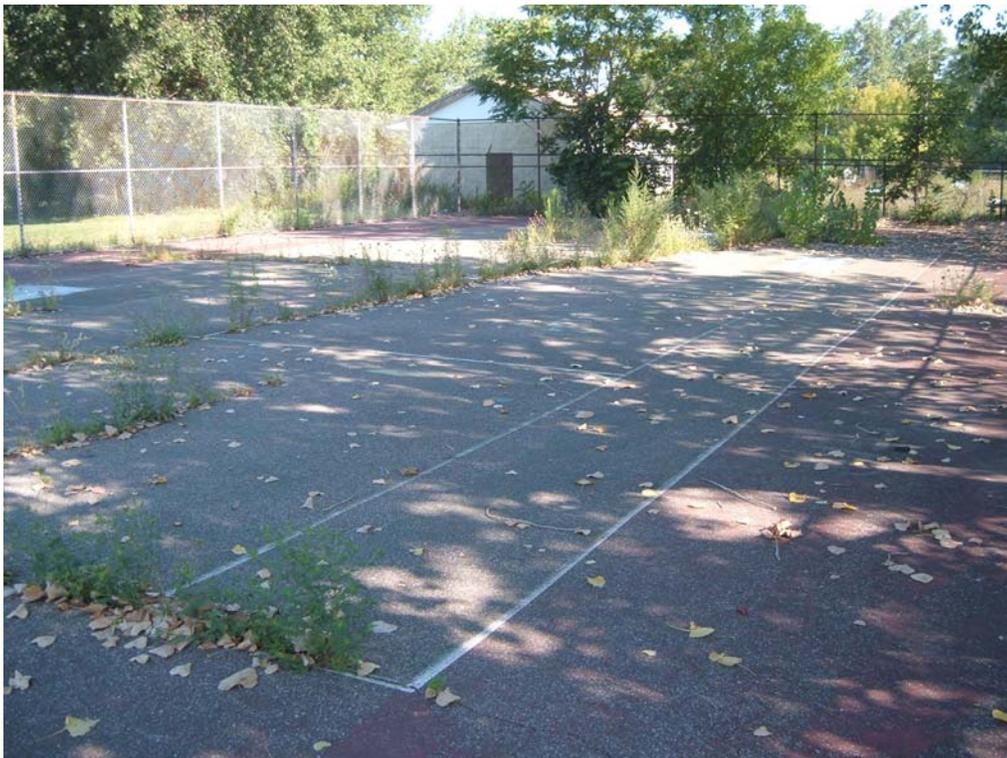
Once again, Father Conway Park in the Fillmore District. This photo of the tennis courts and fencing shows why this park was the lowest rated park in the audit. Since the visit of the audit team, this court was dug up and removed from the park.

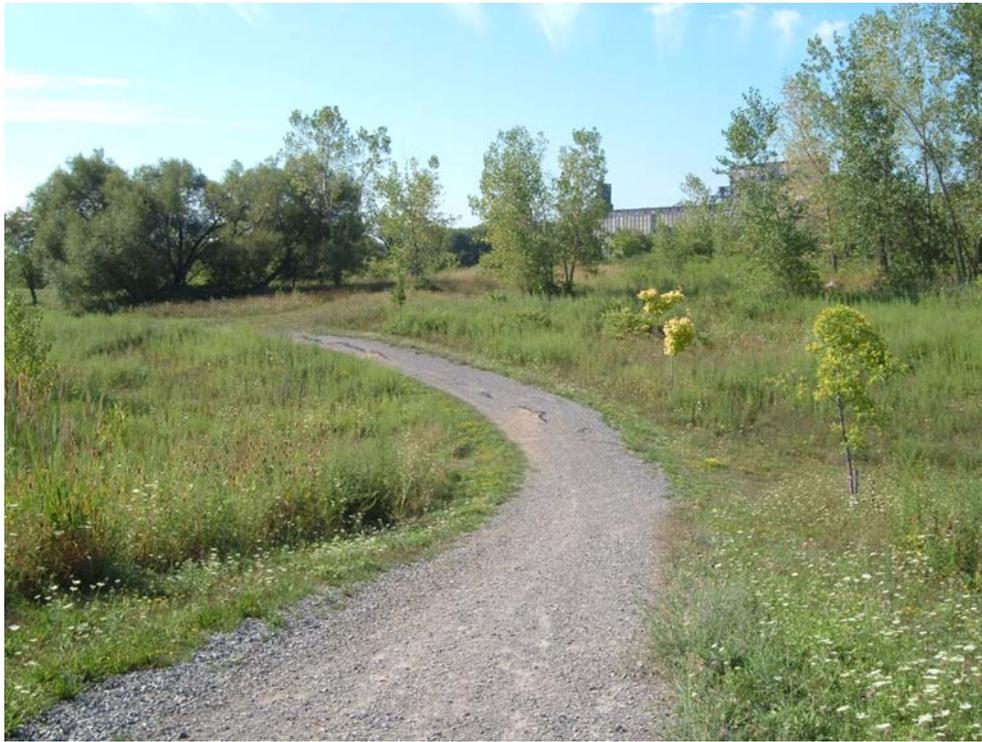
A view along a path along the Valley Nature Trail, located in the Fillmore District. This really is one of Buffalo's hidden treasures. A note to those who would walk these paths; they are longer than you would expect.

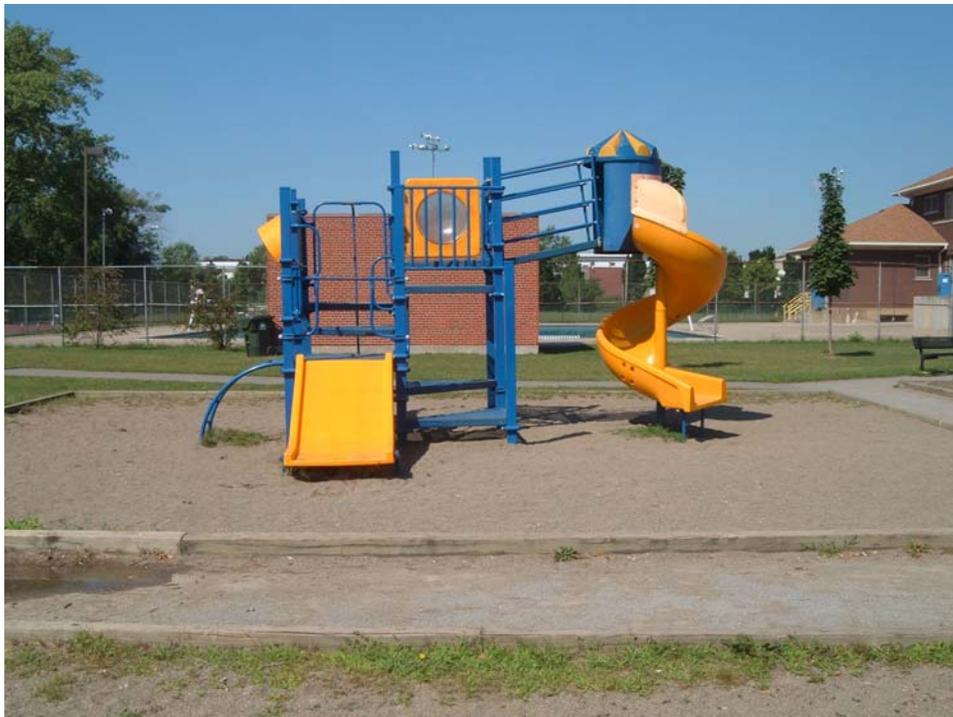
The play area at Stachowski-Houghton Park in the South District. A very clean and well-maintained play area, lacking only sand or wood chips for the base. This is one notch away from flawless. Please also note the operational pool in the background.

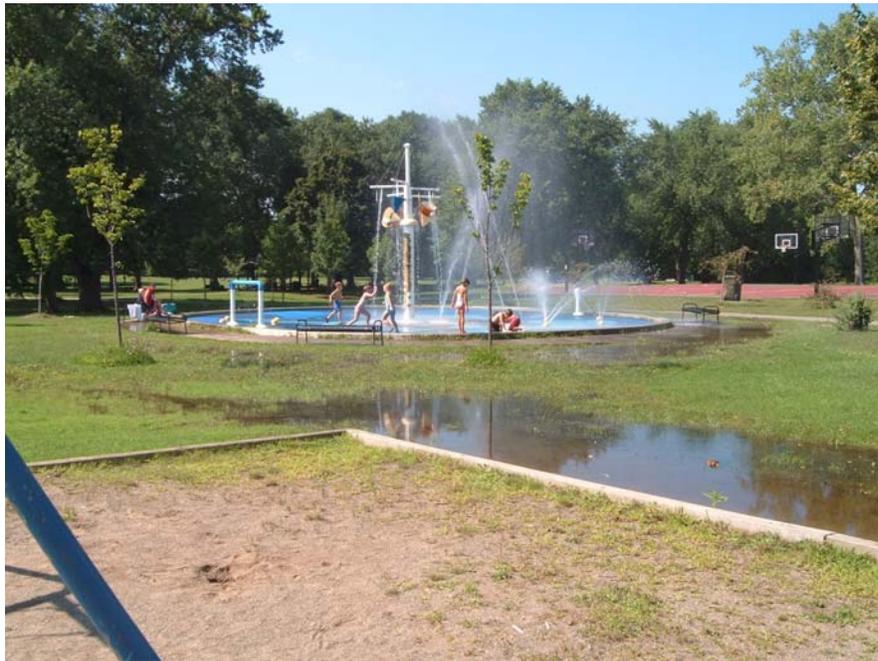
Another view of Stachowski-Houghton Park in the South District, showing the splash pool. Although an underground pipe was leaking at the time of our visit, the splash pool is still operational and in use. The puddle in the foreground is a result of the broken pipe. The basketball courts in the background are in excellent condition.

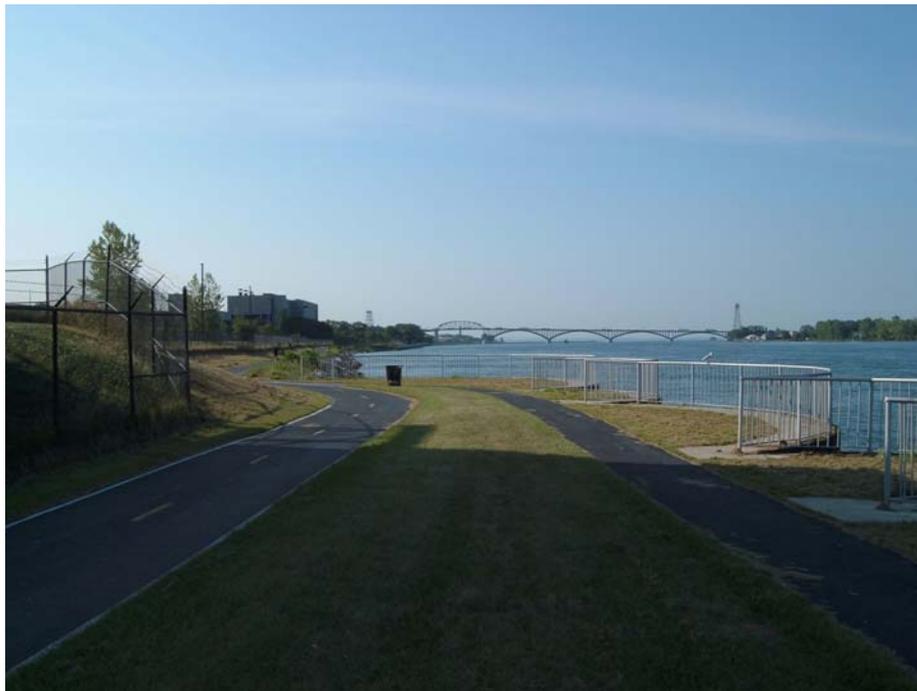
Below is a view from the Squaw Island Park bike path in the Niagara District. The view is looking west toward the Peace Bridge. This path is well used by bikers, runners and the US Border Patrol. (The trees in the right background are in Canada.) Other than some graffiti, this is a beautiful path to exercise on and very popular with the local fishermen. The path from this point to the end of the breakwater is about two and one-half miles.

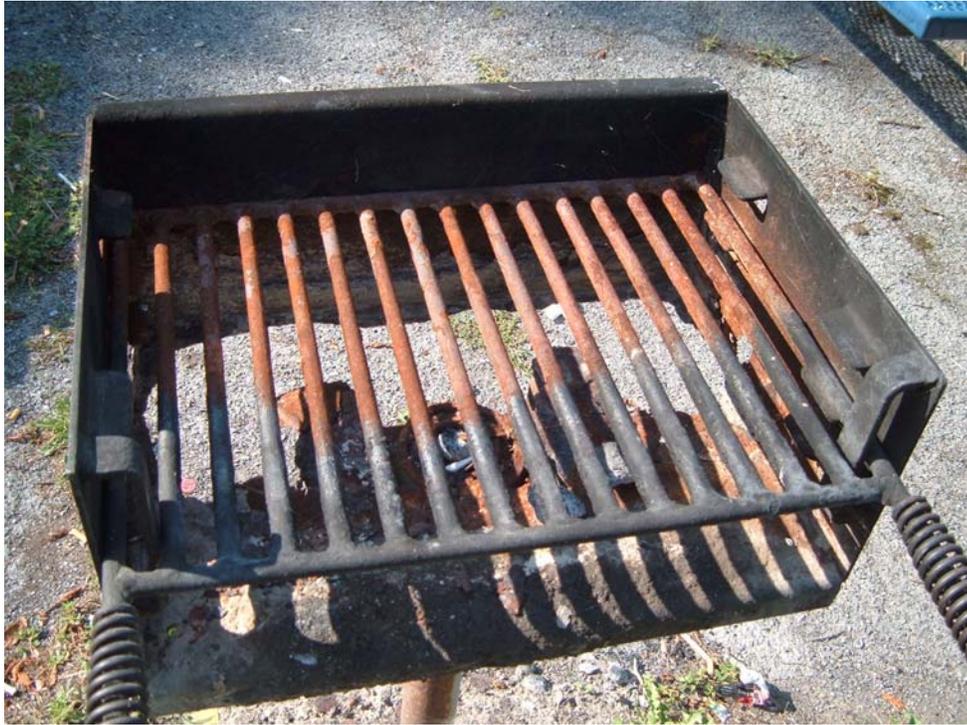
One of the outdoor grills at Broderick Park, in the Niagara District. It is badly in need of replacement.

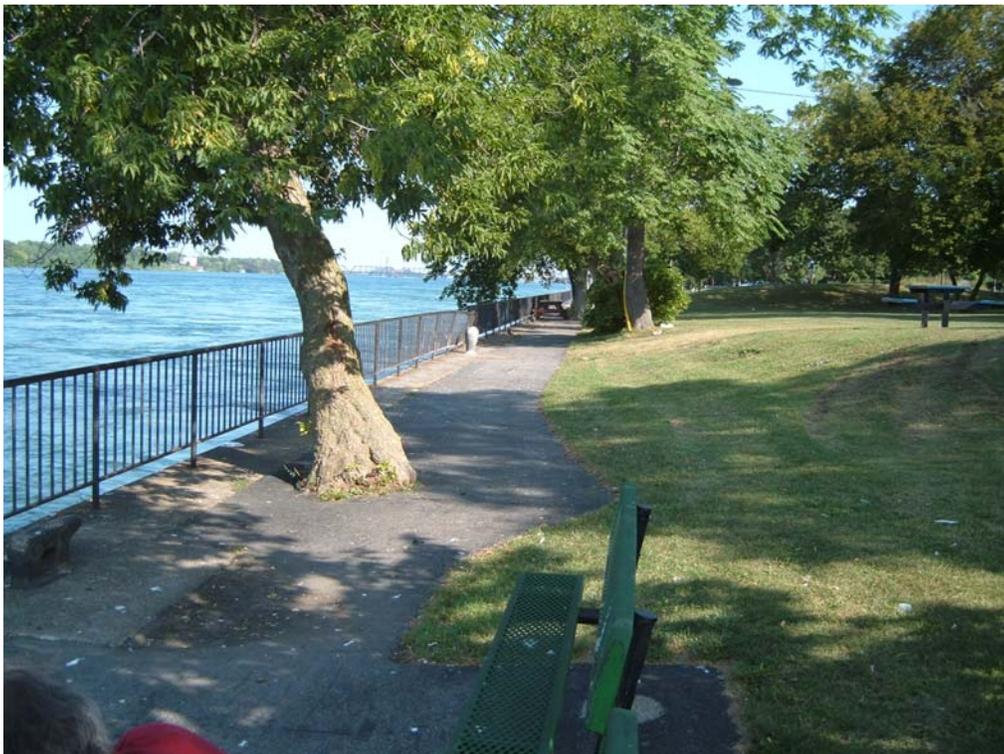
This is another view of Broderick Park in the Niagara District. This is a lovely park marred only by the graffiti and litter.

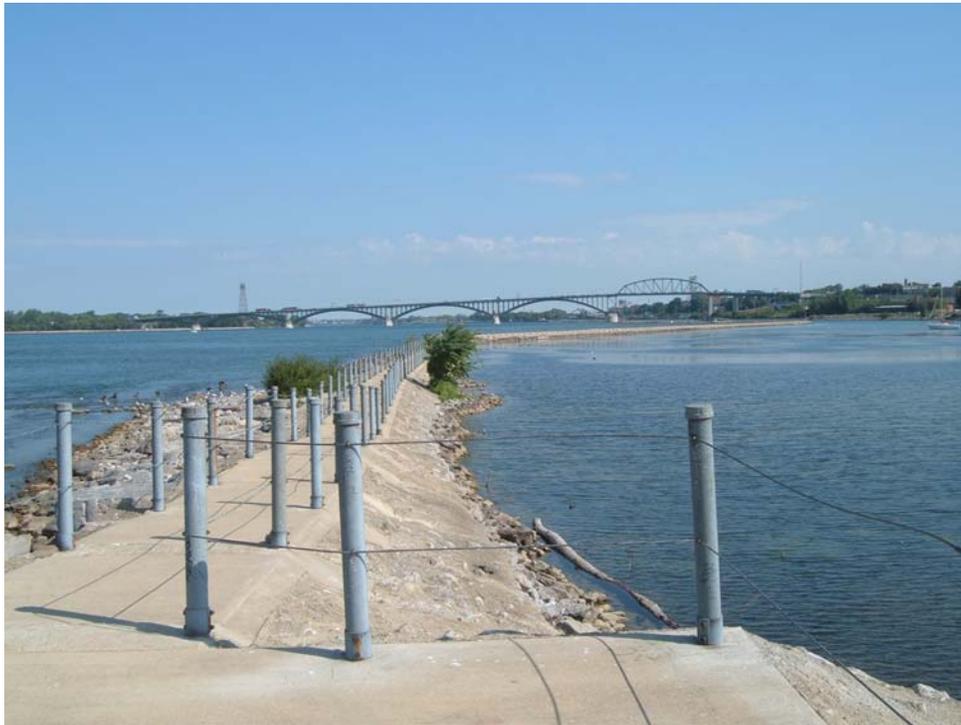
A view most people seldom see – the very end of the breakwater leading from Broderick Park. Please compare this view to that photo taken from Squaw Island Park. A walk not for the faint of heart, the view is excellent. There is some graffiti and some litter.

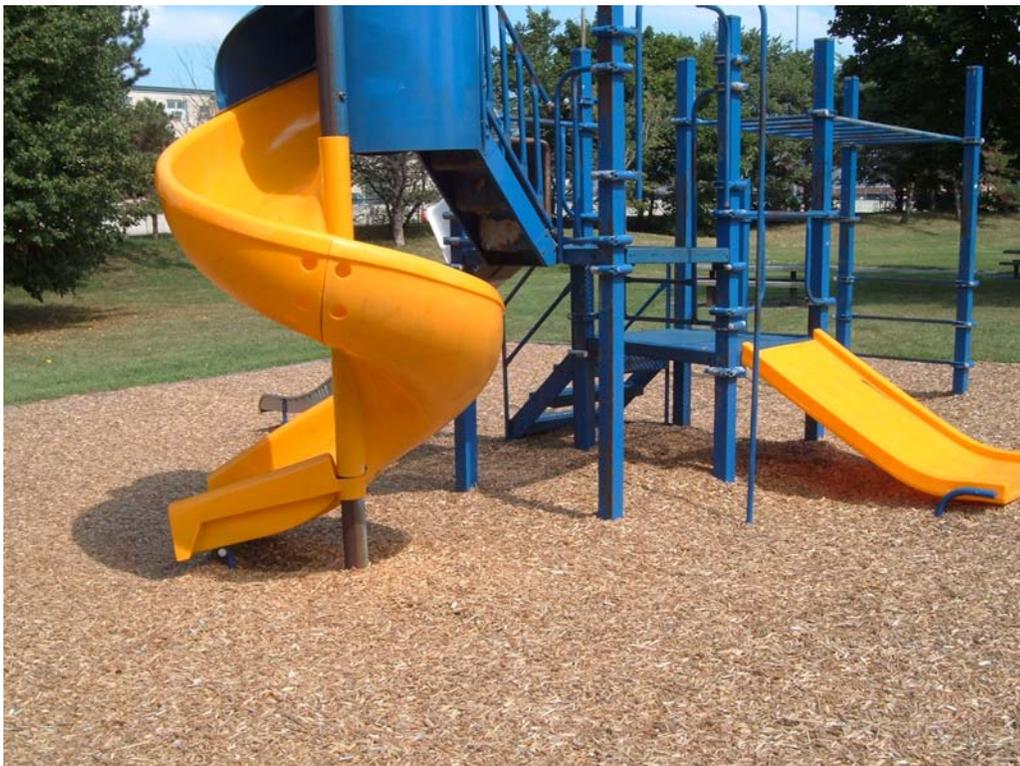
Can you tell that this playground is located in an Olmsted Park? This area is in Front Park, in the Niagara District. Flawless.

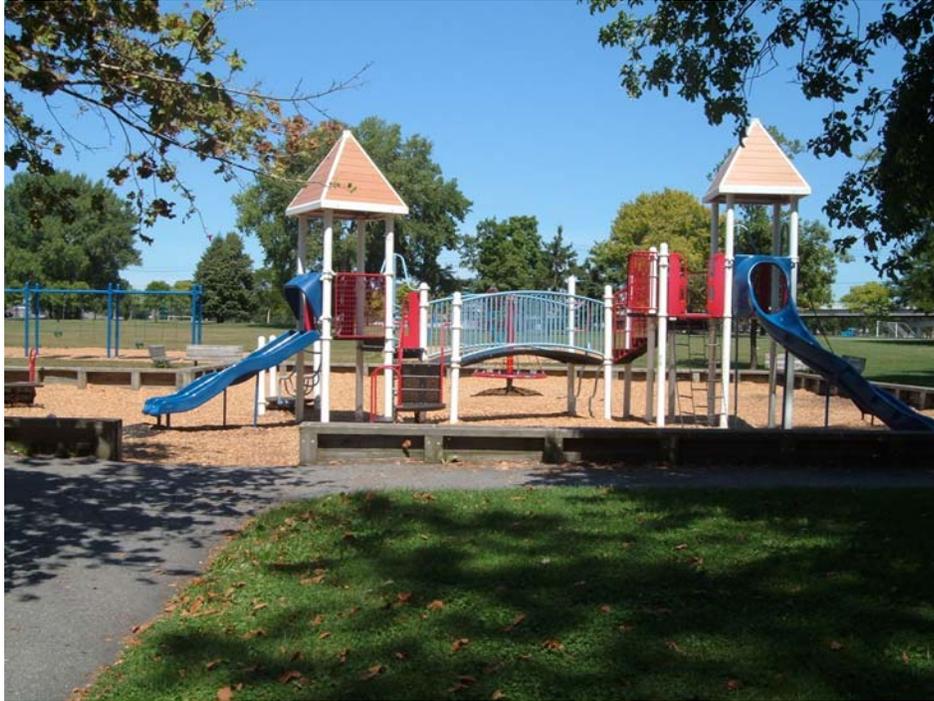
LaSalle Park, in the Ellicott District. This area was in very good condition. Some graffiti was evident, but the area has been well maintained.

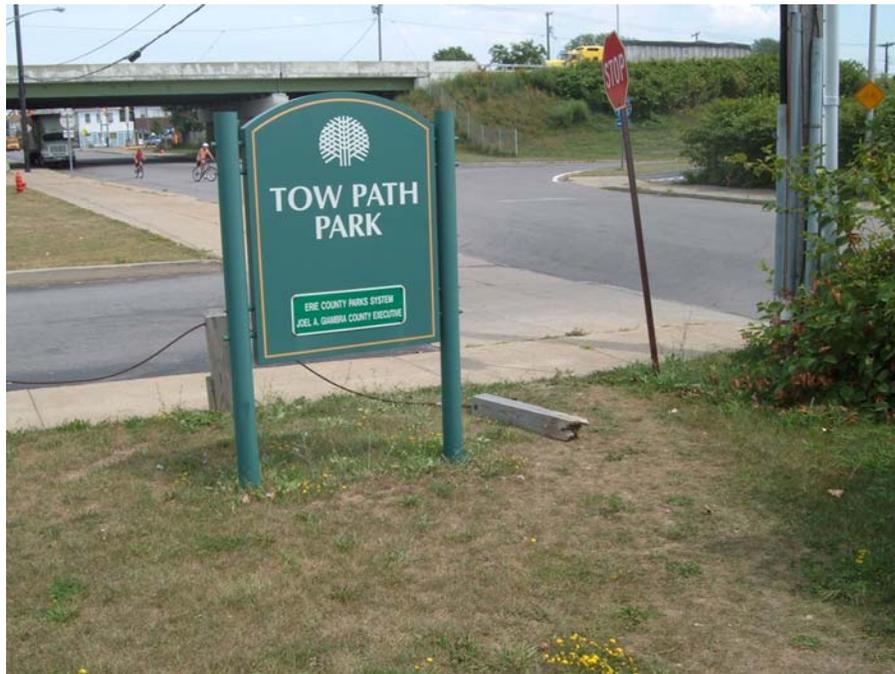
Below is an example of the signage the City uses to identify its parks. The signs were well-placed and in excellent condition throughout our audit. This location is Towpath Park in the North District.
